**Window & Door Replacement****FIELD REPORT #**1**Date:** 30-Sep-20

Dunes Of Panama  
7205 Thomas Dr  
Panama City Beach, FL 32408

**WORK IN PROGRESS**

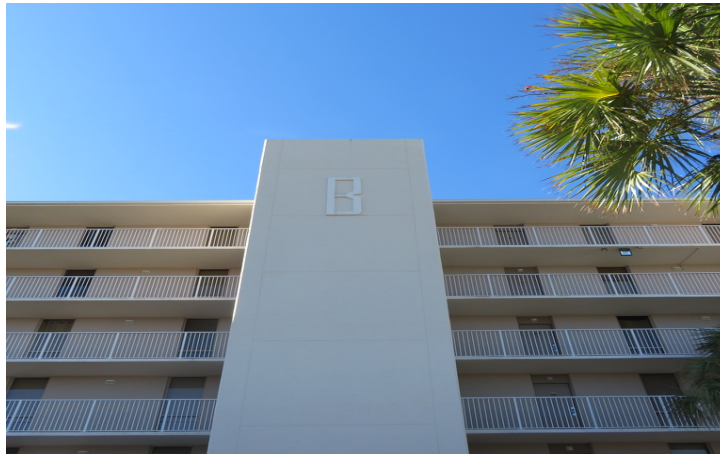
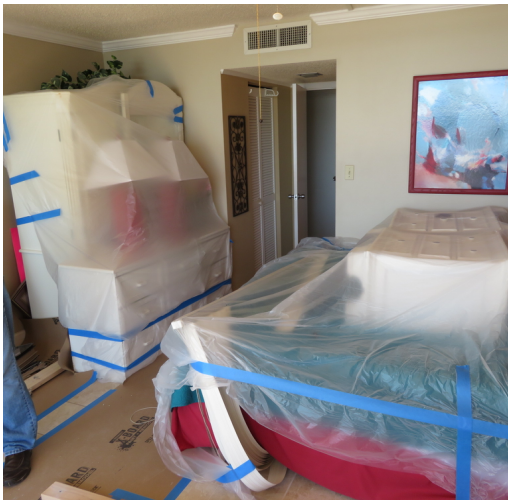
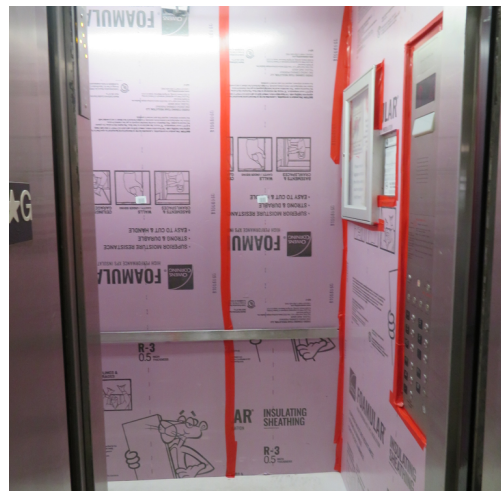
Dunes of Panama maintenance team removed window dressings, & moved furniture away from work area. Ram board was placed on the floors to create a walking path to the sliding doors & windows. Plastic covering was draped over unit furnishings to help protect them from construction dust. Foam board placed in the elevator on the walls & floor for protection.

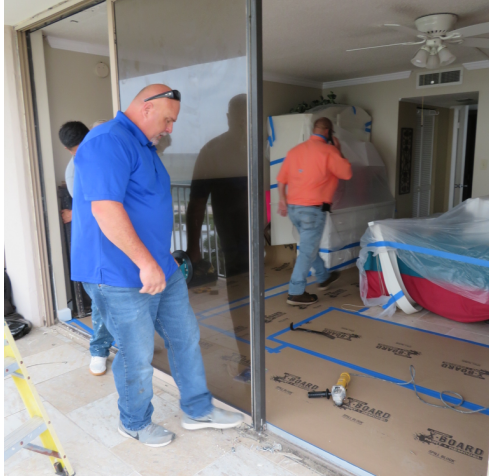
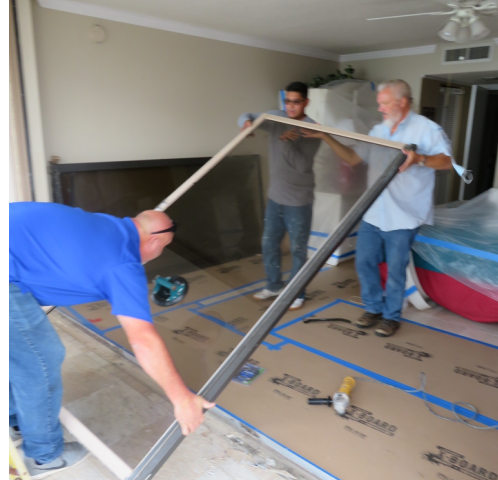
Interior & exterior sealants around the door frame are removed. Glass panels are then removed and carefully placed to the side.

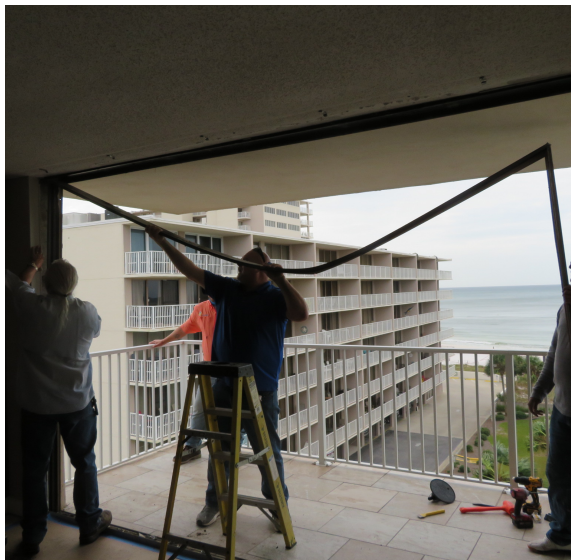
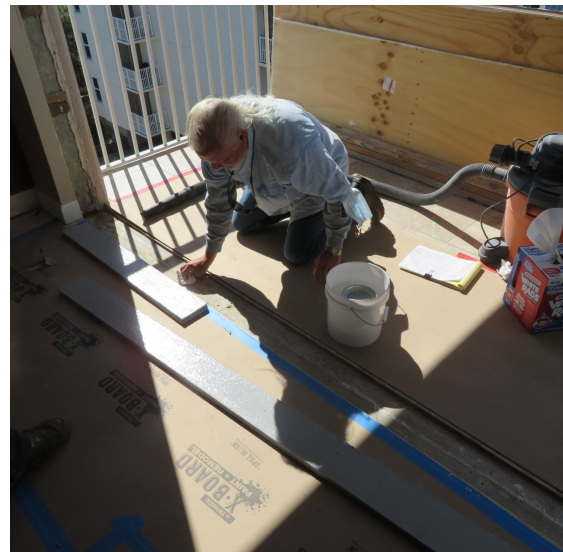
Door frames were then removed one side at a time to expose rough opening. Exterior tile was cut back to accommodate for new thresholds. Opening was then thoroughly vacuumed & wiped clean of any debris.

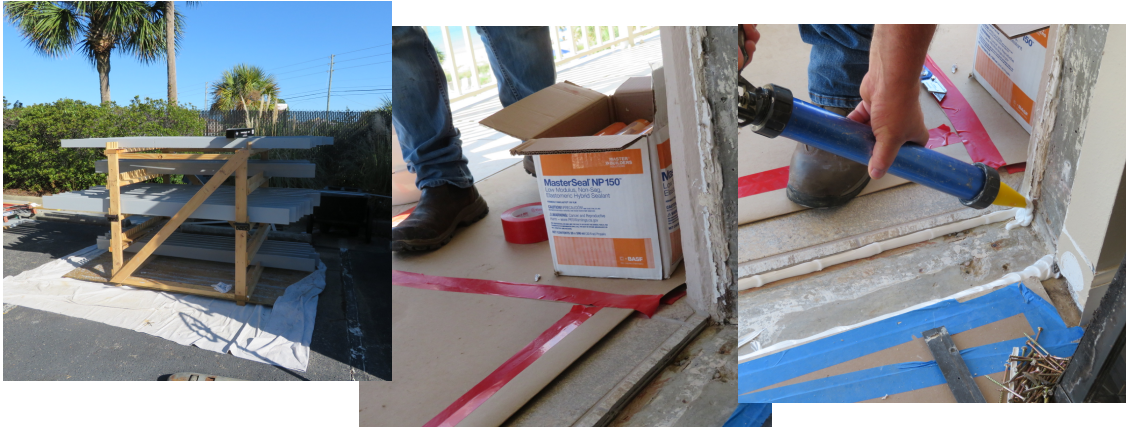
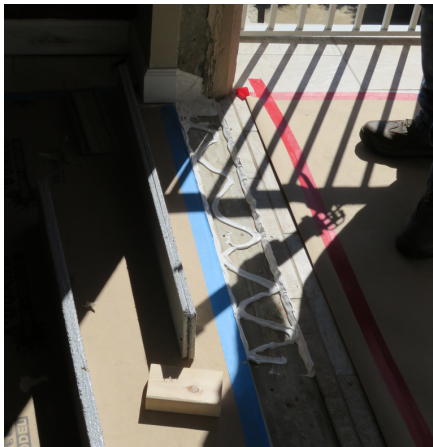
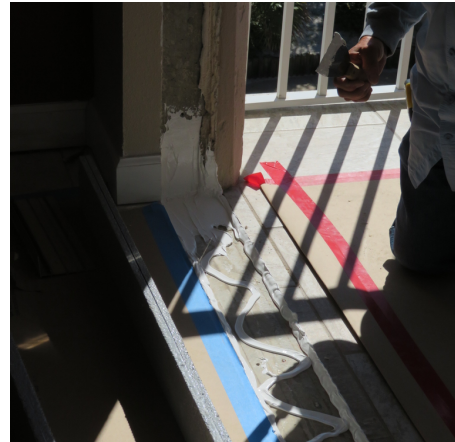
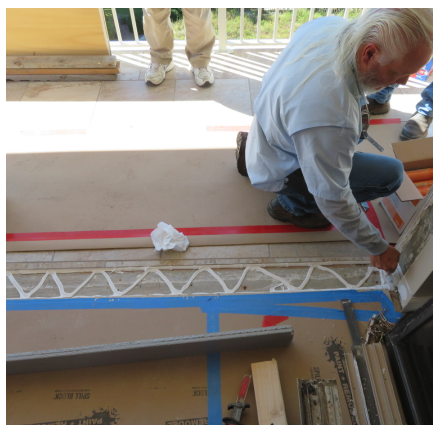
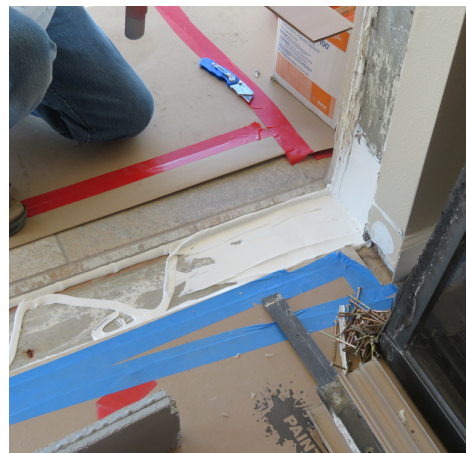
PermaBase cut to size, coated, then place on drying rack to cure. A bead of BASF NP 150 sealant is placed on both sides of rough opening, a 'Z' pattern throughout the middle, & 6" up the sides to aid in waterproofing.

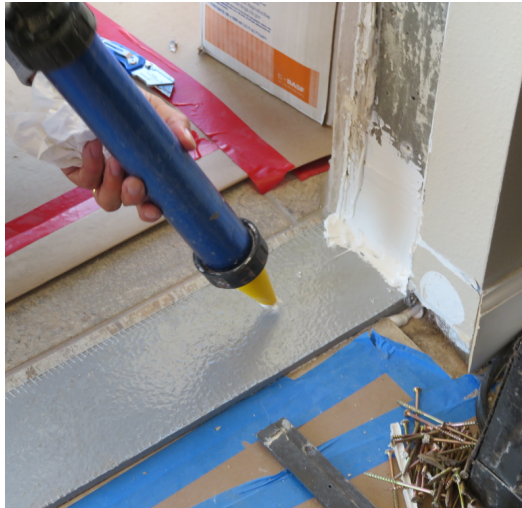
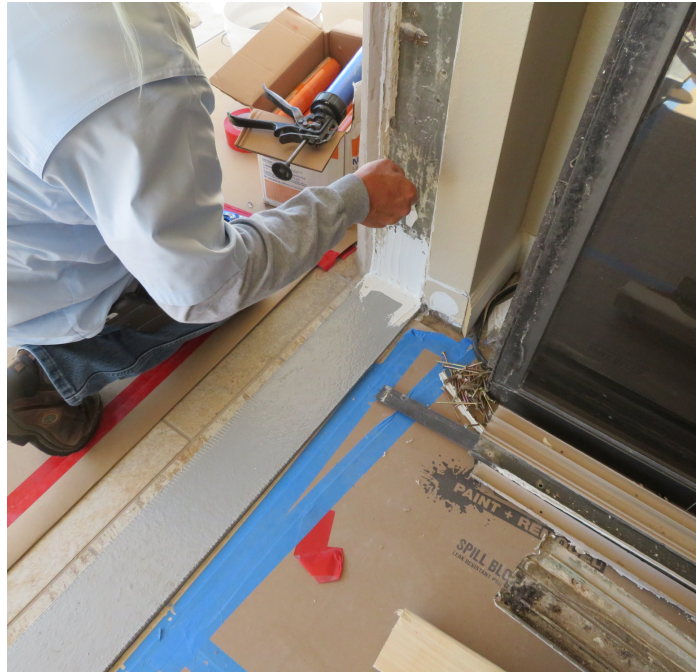
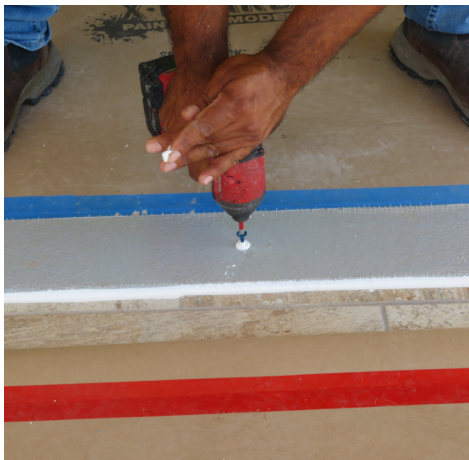
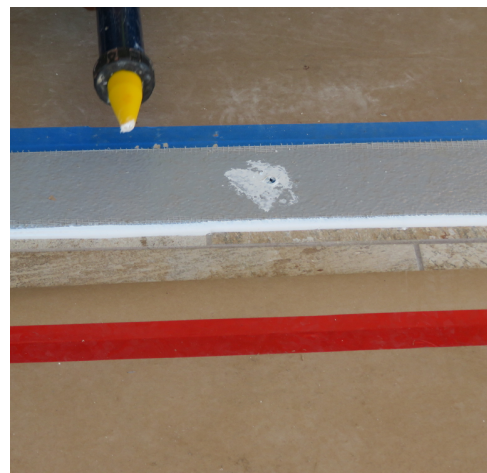
Perma base is then placed into the opening & additional sealant is placed on top of the perma base as well as the anchor head to ensure a water tight seal.
